Re: Compliance Evaluation Inspections  
Concrete Supply Company, Lincolnton, NC  
NPDES Permit No. NCG140046

## Water Compliance Inspection Report

Concrete Supply Company - Lincolnton Plant

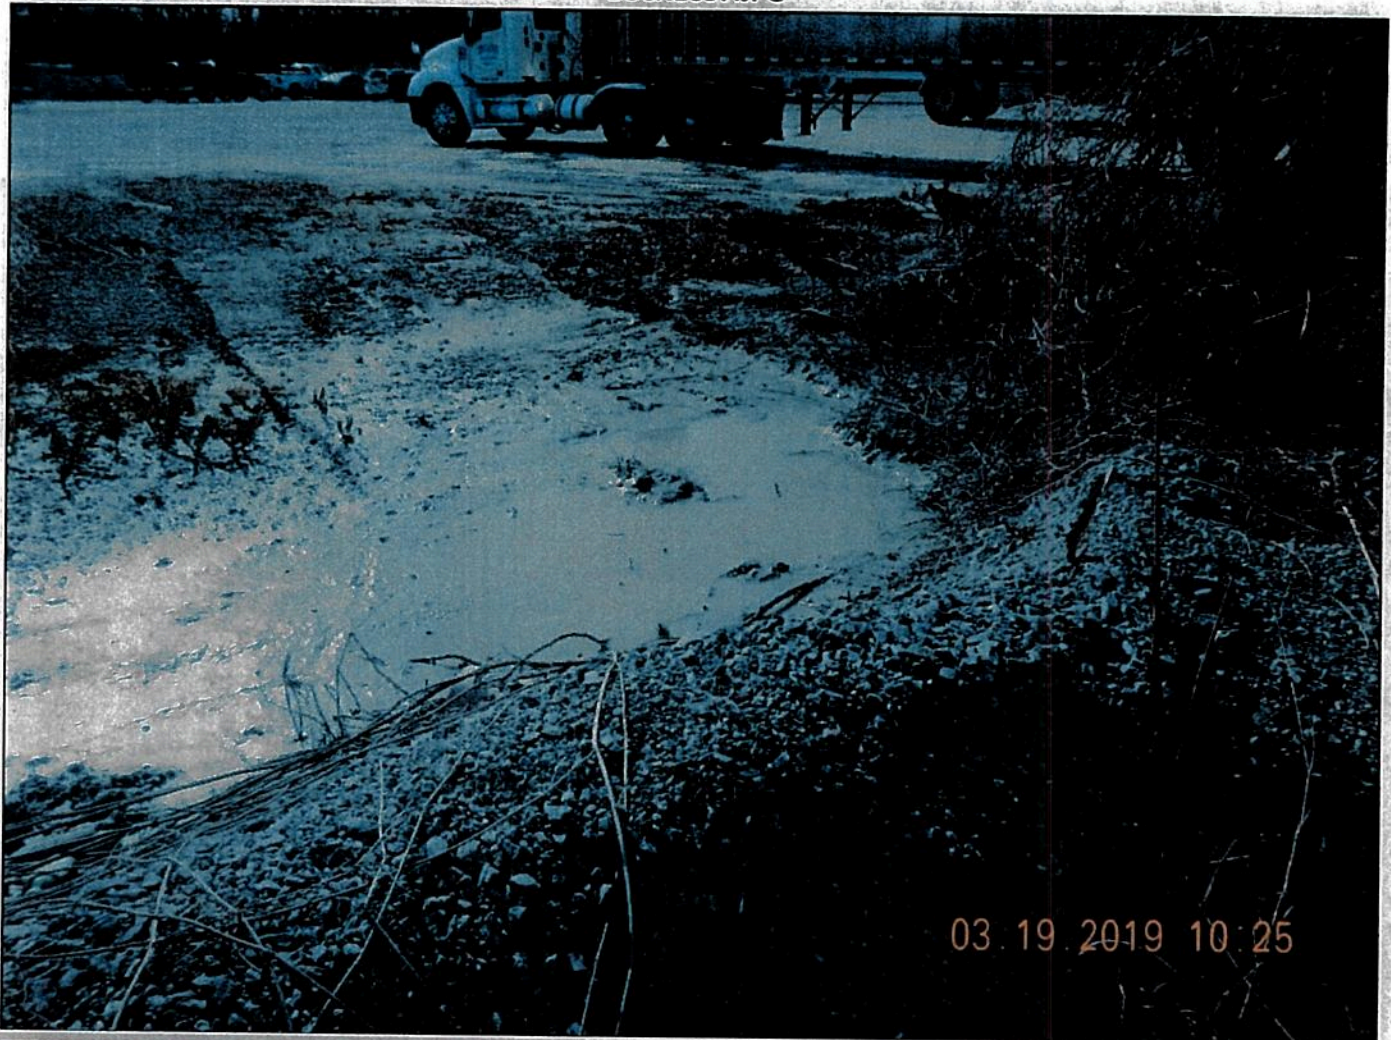
File Name	DSCN1837.JPG
Description	Photograph of the bermed area and inlet at Outfall 1. This outfall, located in the northwest corner of the site, has the potential to discharge both stormwater and wastewater.
Latitude	N 35° 27' 40.60"
Longitude	W 81° 15' 38.43"

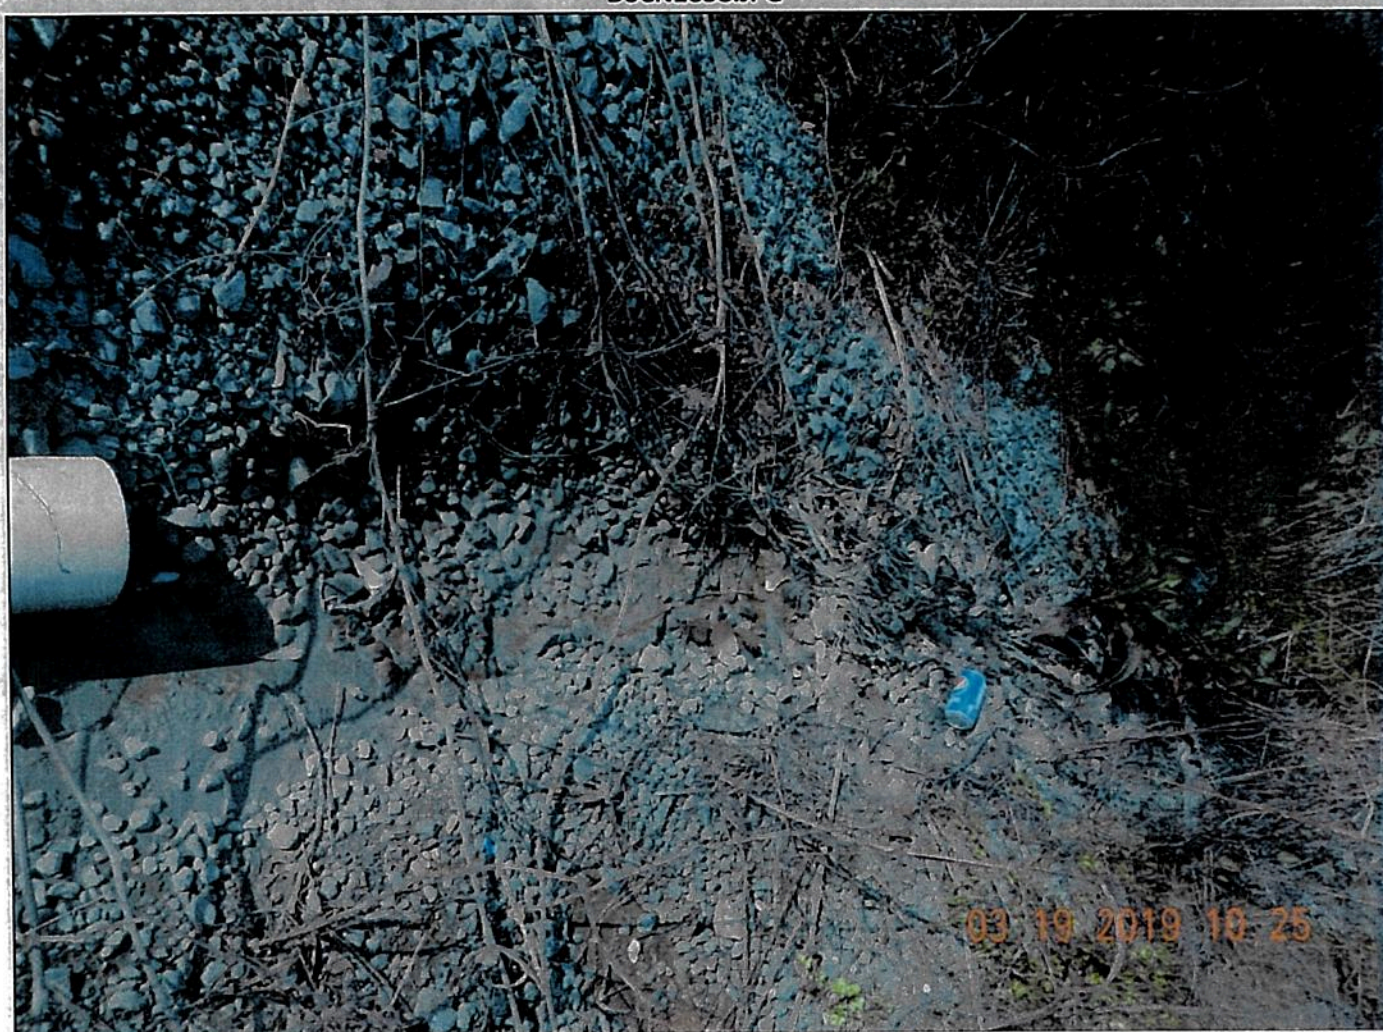
File Name	DSCN1838.JPG
Description	Photograph of the outlet for Outfall 1. This outfall, located in the northwest corner of the site, has the potential to discharge both stormwater and wastewater. The area downgradient of the outfall had what appeared to be accumulated silty material from the concrete process.
Latitude	N 35° 27' 41.38"
Longitude	W 81° 15' 40.91"

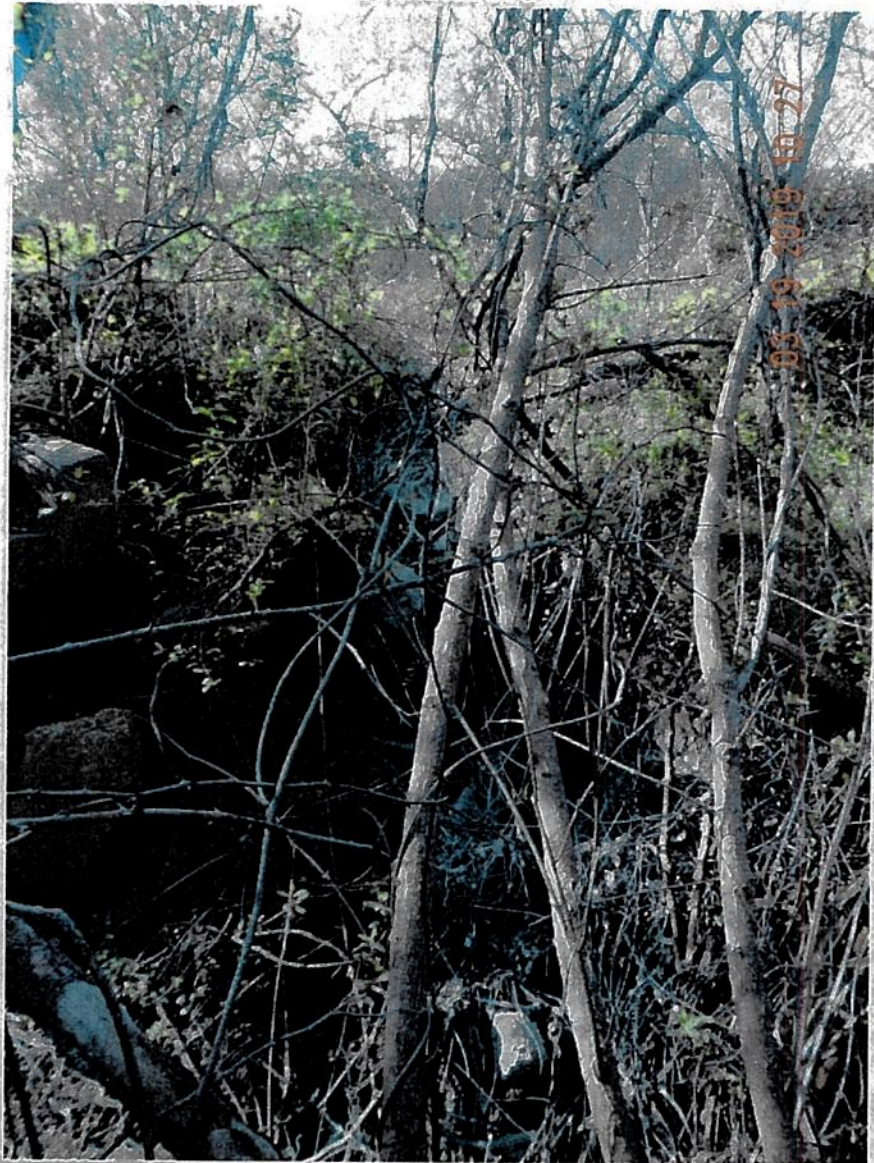
File Name	DSCN1839.JPG
Description	Photograph of the ditch down gradient of Outfall 1 leading towards the creek. This area appeared to be accumulated silty material from the concrete process. Pooling water was observed in locations in the ditch in addition to the evidence of erosion features.
Latitude	N 35° 27' 39.65"
Longitude	W 81° 15' 38.42"

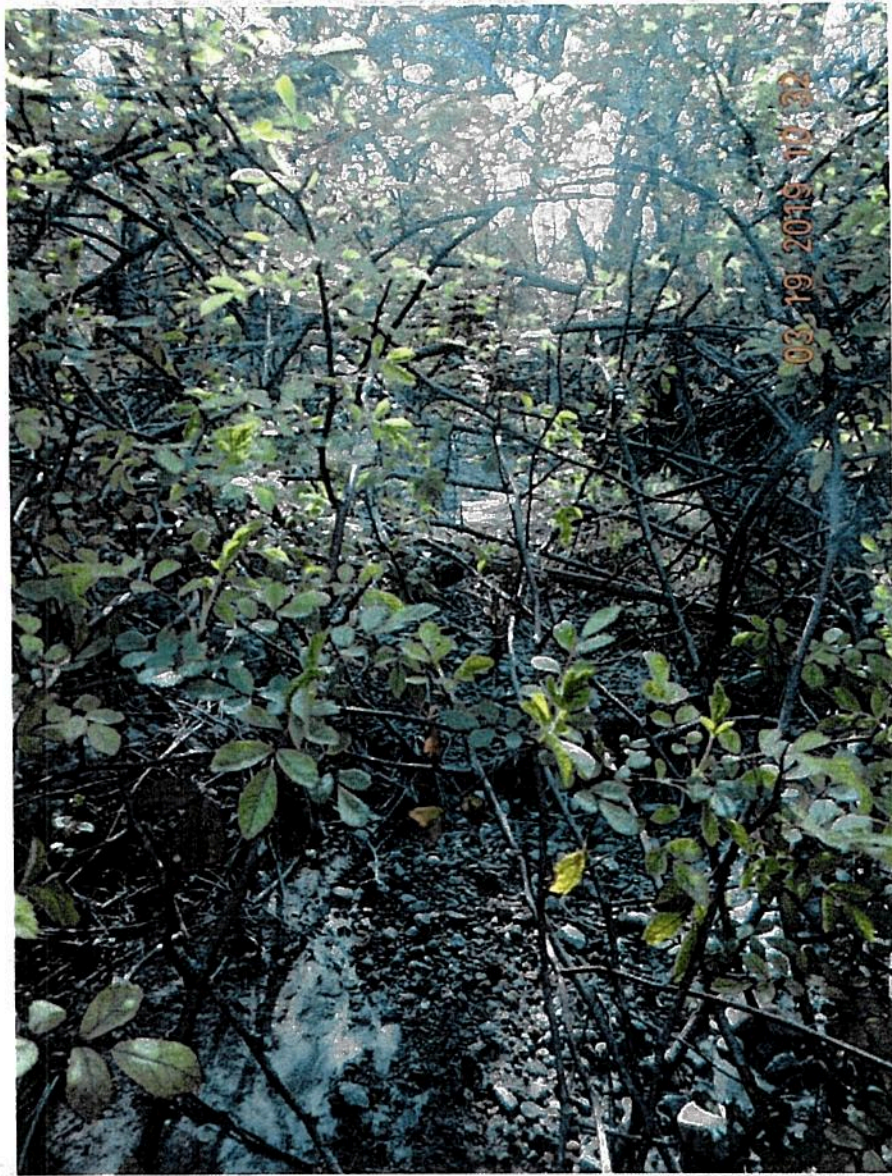
File Name	DSCN1840.JPG
Description	Photograph of the ditch down gradient of Outfall 1 leading towards the creek. Pooling water was observed in locations in the ditch in addition to the evidence of erosion features.
Latitude	N 35° 27' 40.00"
Longitude	W 81° 15' 38.26"

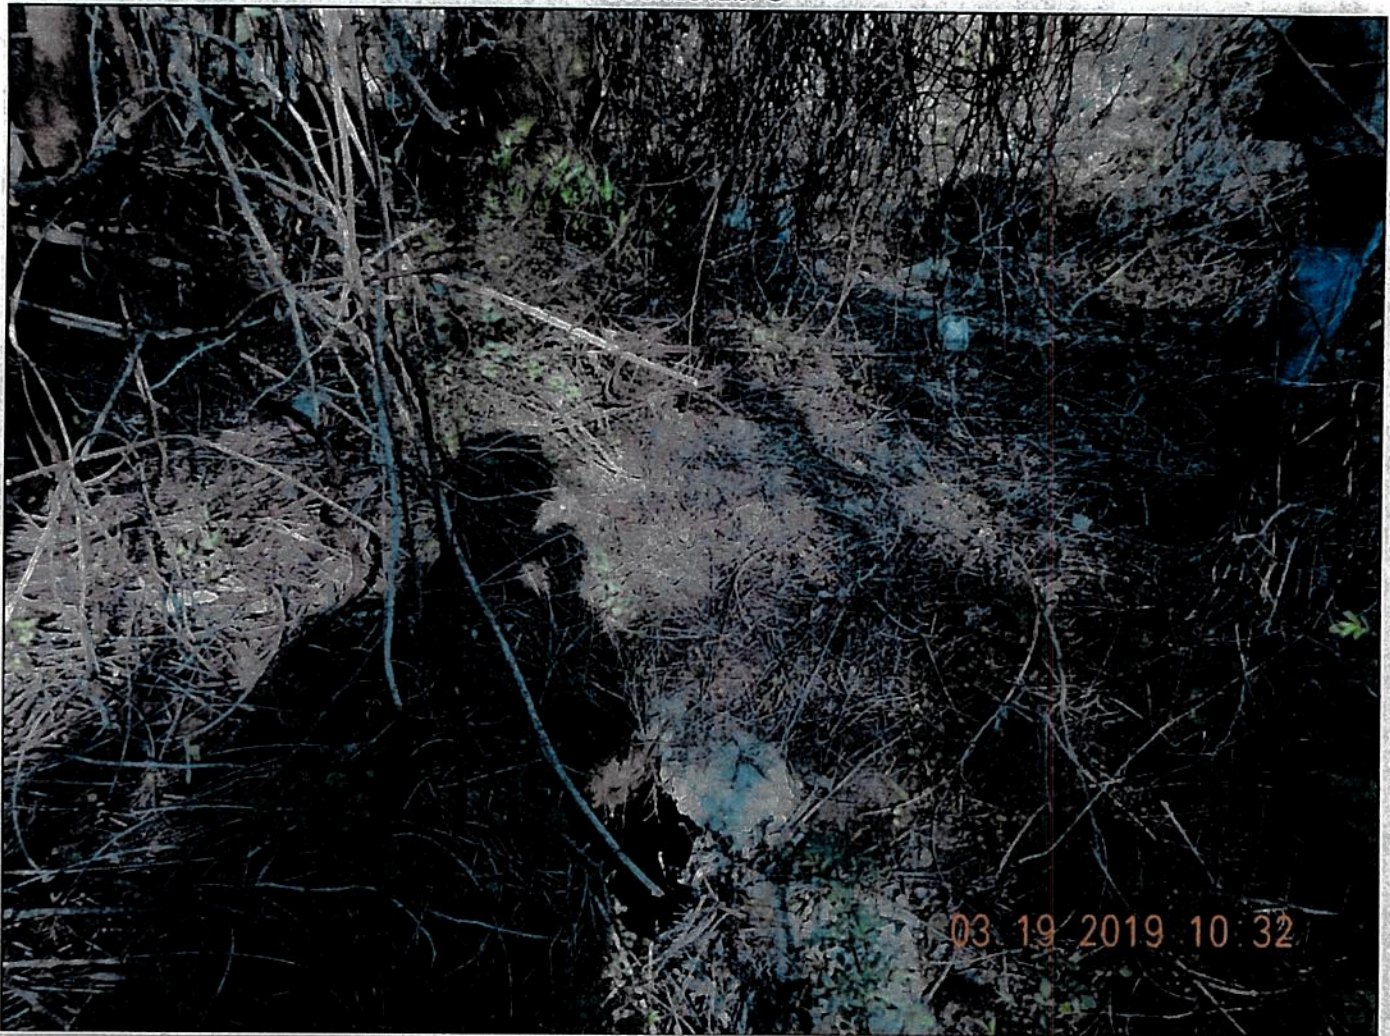
File Name	DSCN1841.JPG
Description	Photograph of the ditch down gradient of Outfall 1 leading towards the creek. Pooling water was observed in locations in the ditch in addition to the evidence of erosion features.
Latitude	N 35° 27' 39.98"
Longitude	W 81° 15' 38.25"

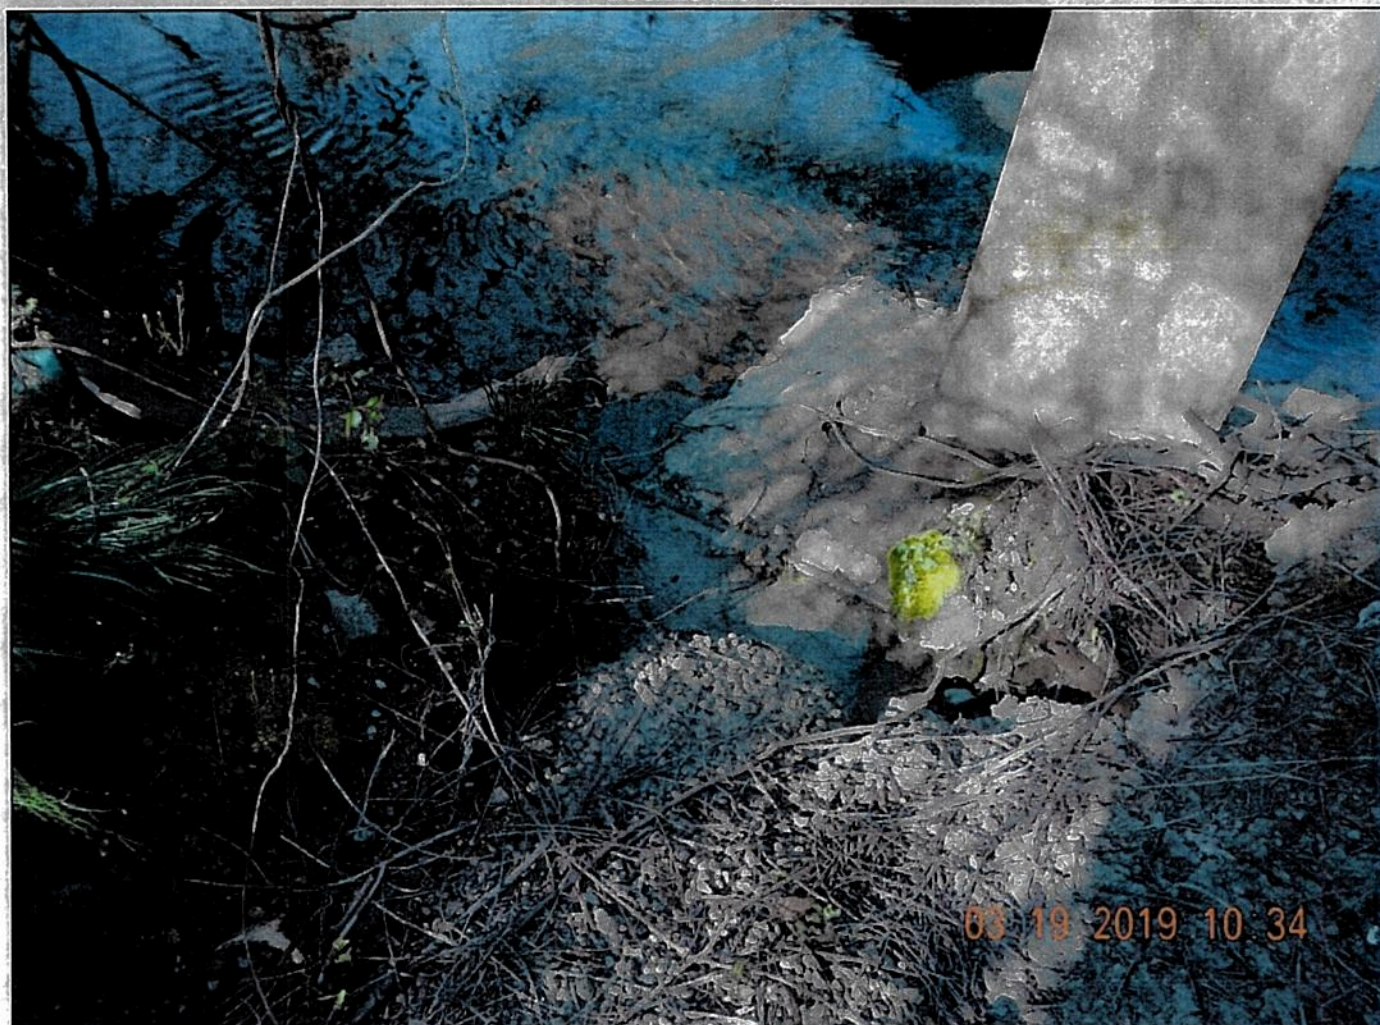
File Name	DSCN1842.JPG
Description	Photograph of the junction between the creek and the ditch down gradient of Outfall 1.
Latitude	N 35° 27' 40.12"
Longitude	W 81° 15' 38.76"

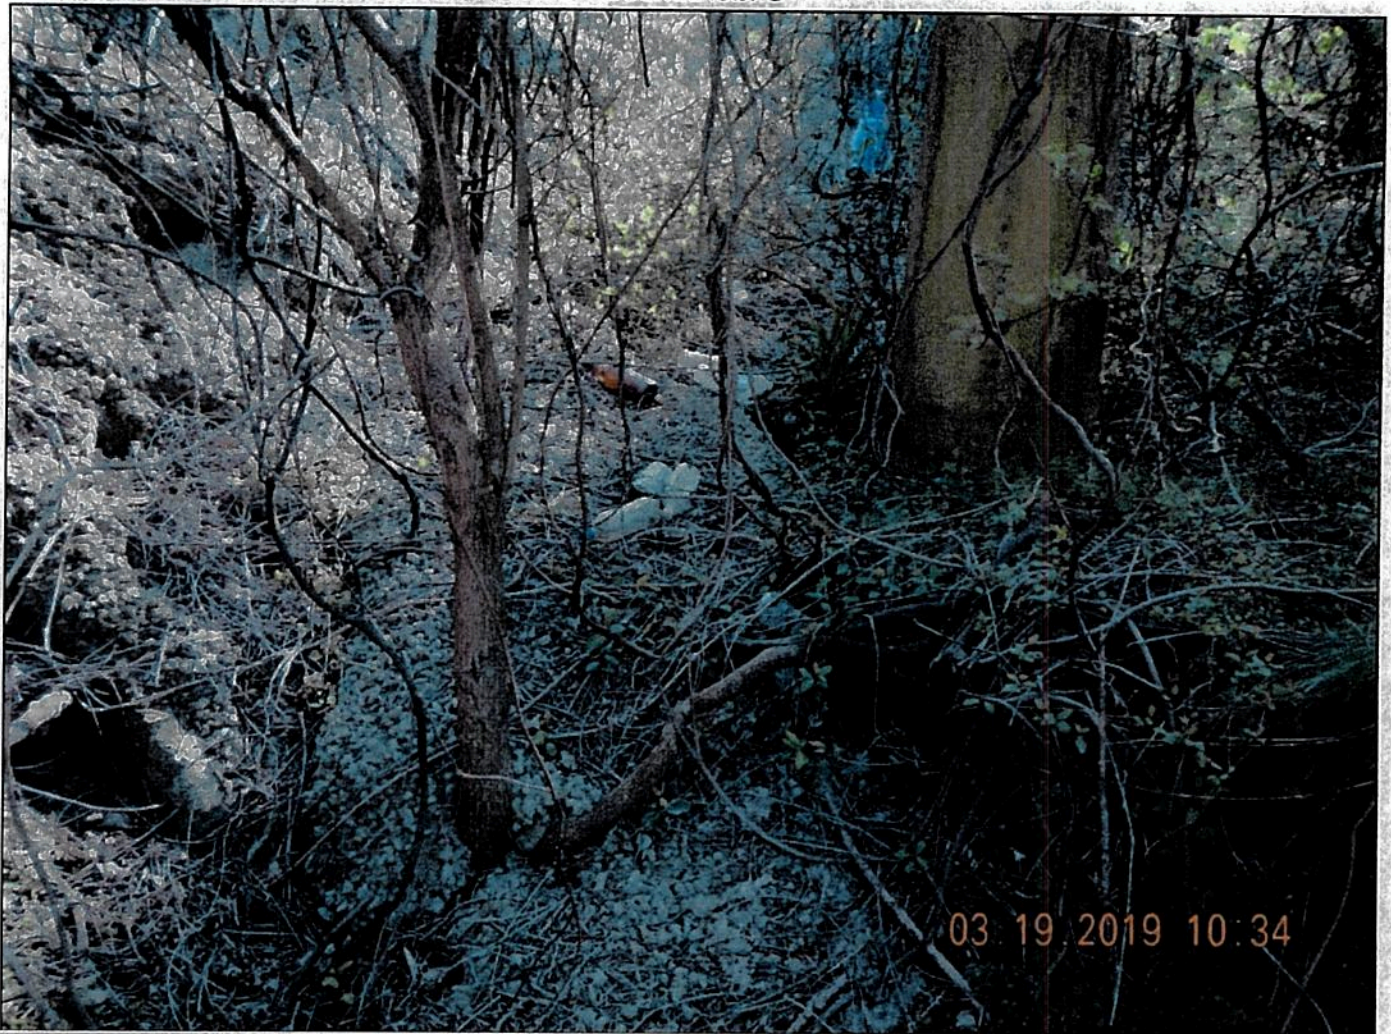
File Name	DSCN1843.JPG
Description	Photograph of the ditch up gradient of junction with the creek.
Latitude	N 35° 27' 40.11"
Longitude	W 81° 15' 38.78"

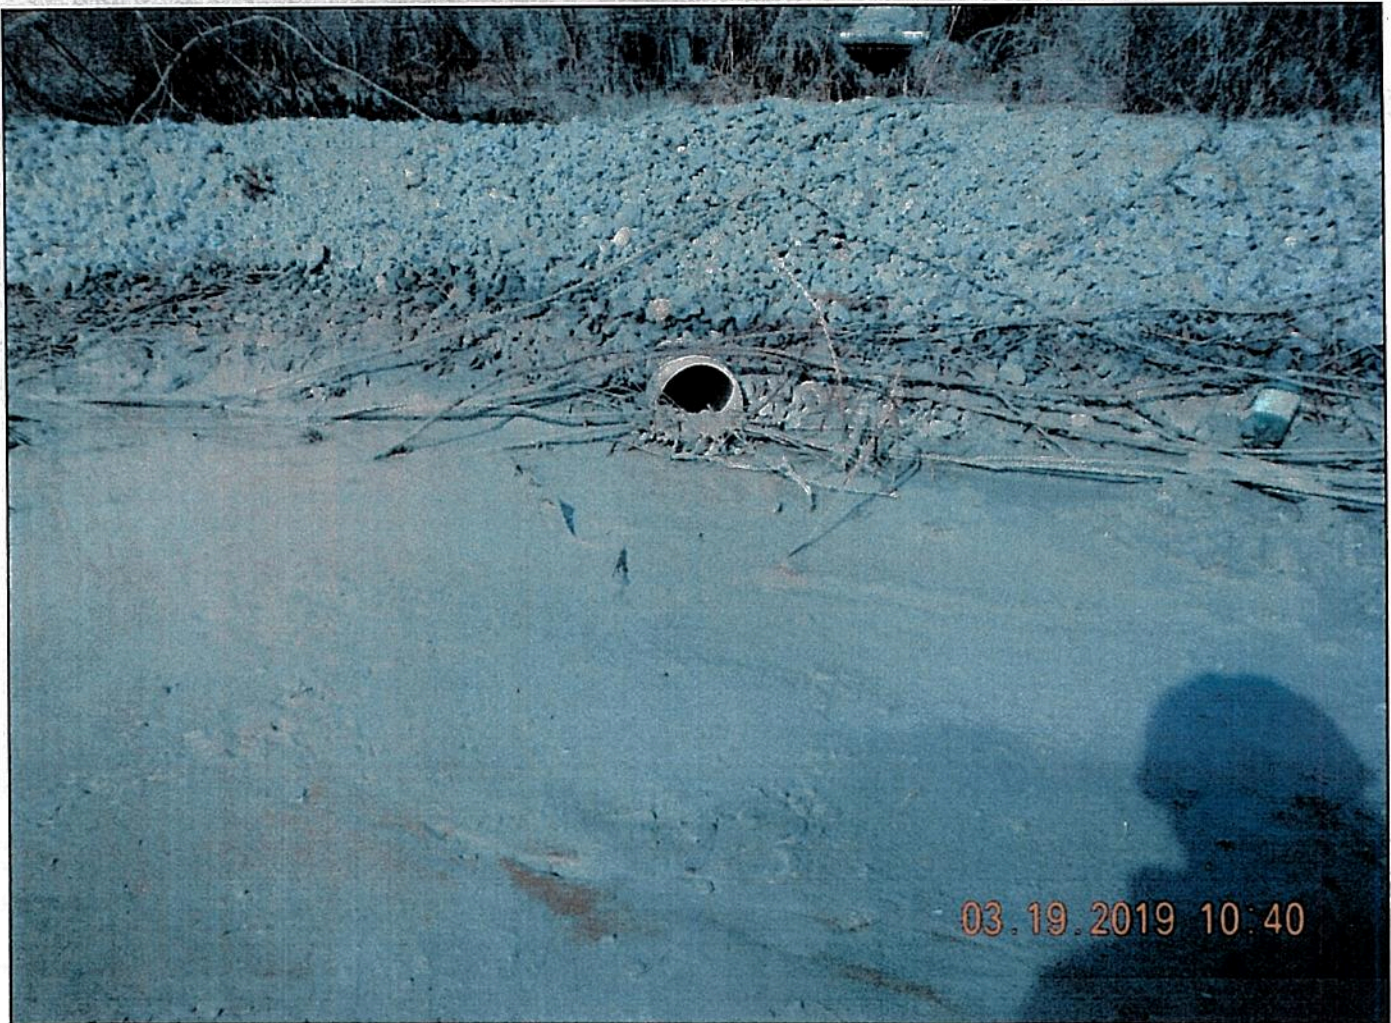
File Name	DSCN1844.JPG
Description	Photograph of the berm and inlet to the pipe for Outfall 1. During the inspection, the facility side of the berm had damp accumulated sediment to the level of the outfall pipe.
Latitude	N 35° 27' 39.54"
Longitude	W 81° 15' 37.48"

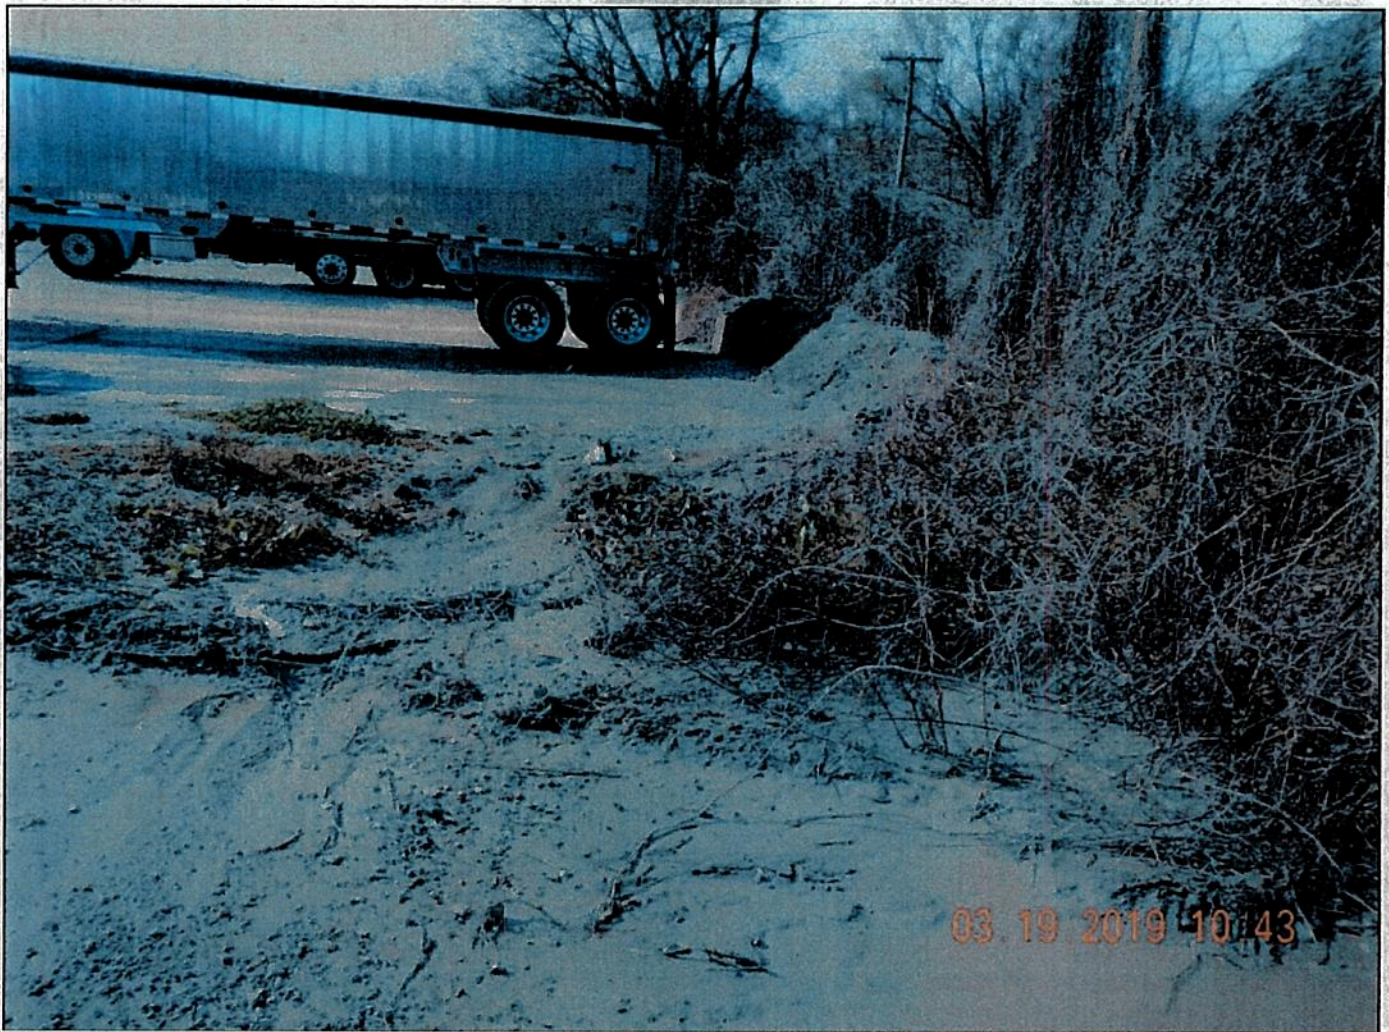
File Name	DSCN1845.JPG
Description	Photograph of the berm along the river near the outfall.
Latitude	N 35° 27' 39.45"
Longitude	W 81° 15' 37.51"

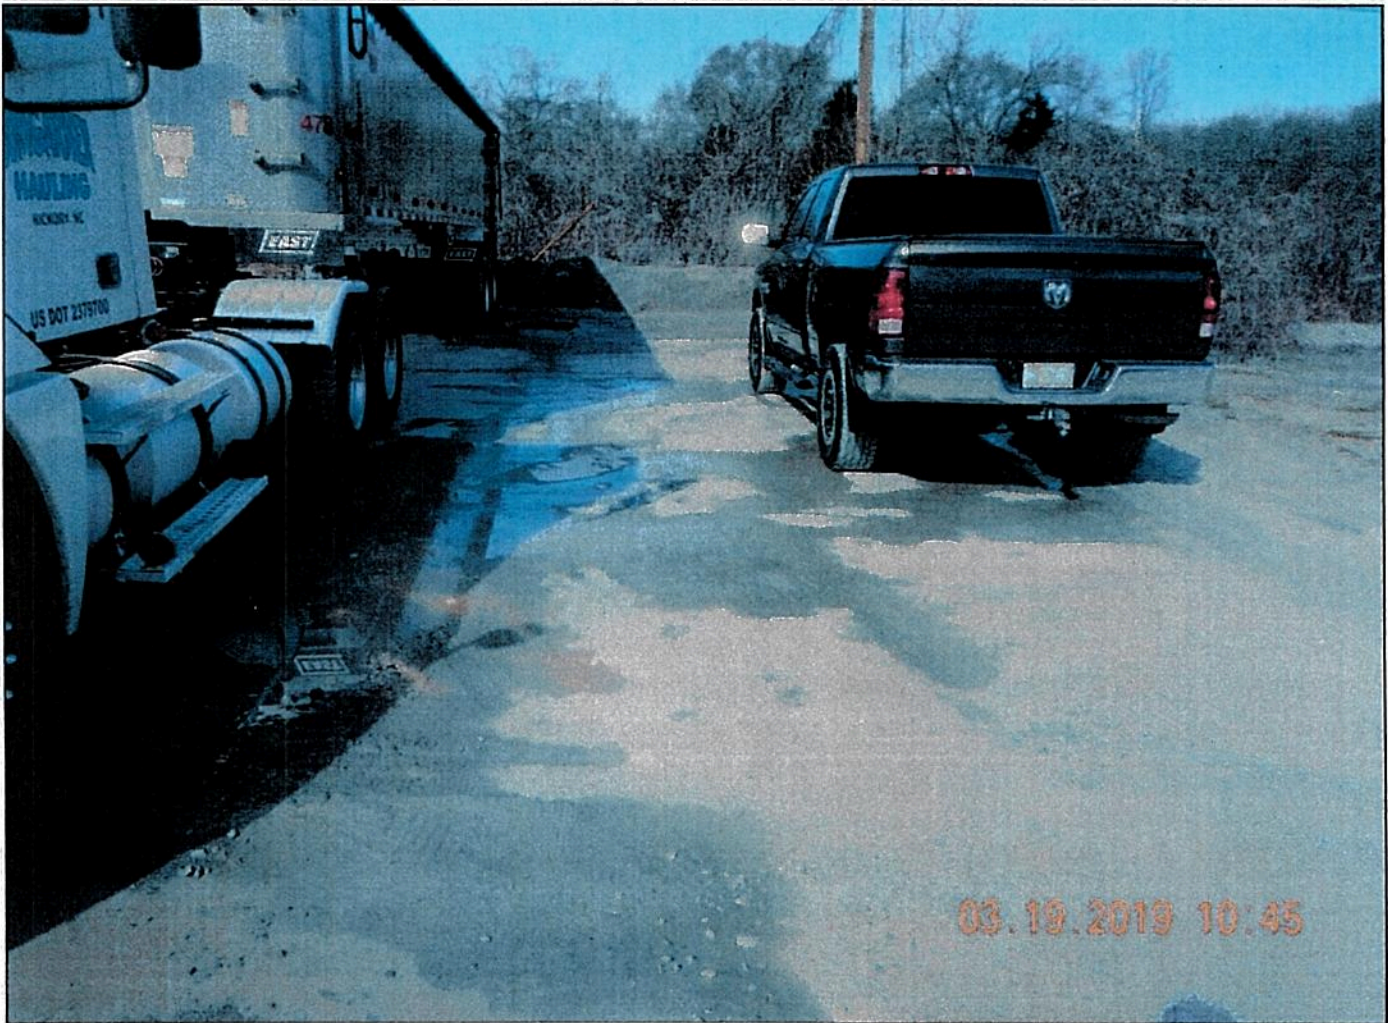
File Name	DSCN1846.JPG
Description	Photograph of wastewater from truck washing operations observed during the site running towards the bermed area near the outfall.
Latitude	N 35° 27' 39.07"
Longitude	W 81° 15' 36.97"

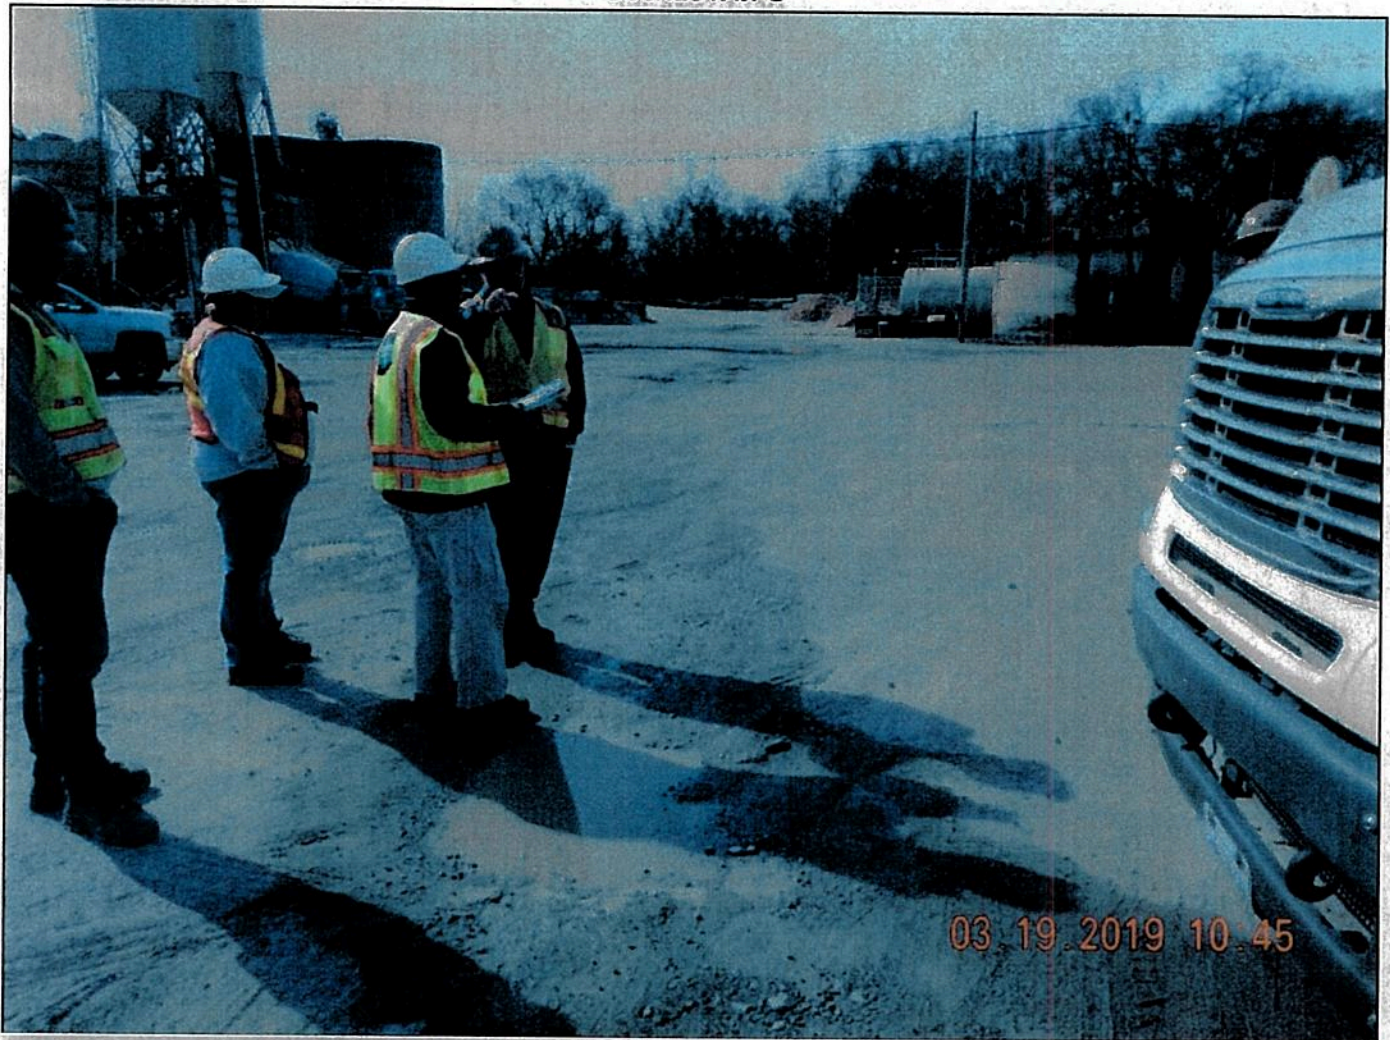
File Name	DSCN1847.JPG
Description	Photograph of wastewater from truck washing operations observed during the site running towards the bermed area near the outfall.
Latitude	N 35° 27' 39.04"
Longitude	W 81° 15' 36.99"

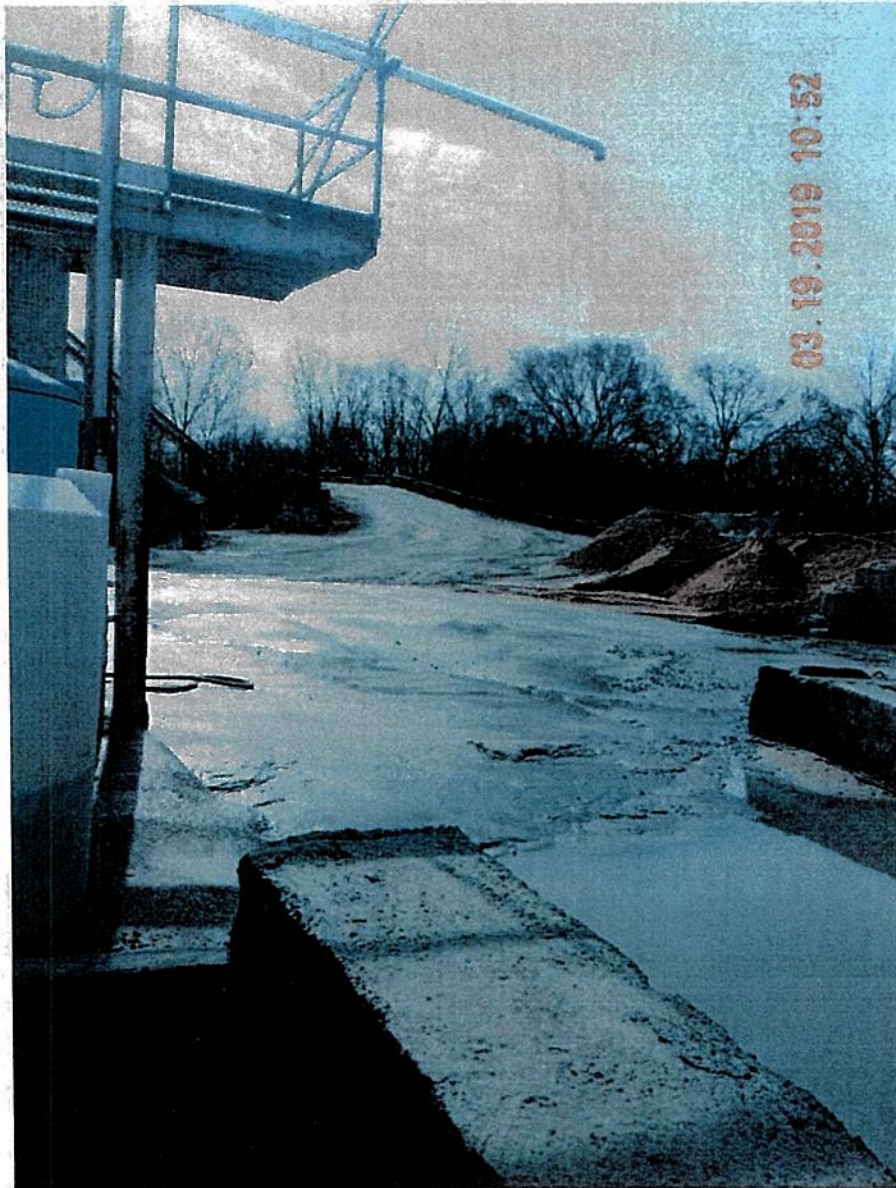
File Name	DSCN1848.JPG
Description	Photograph of the truck wash station near the concrete wash pit.
Latitude	N 35° 27' 36.32"
Longitude	W 81° 15' 39.12"

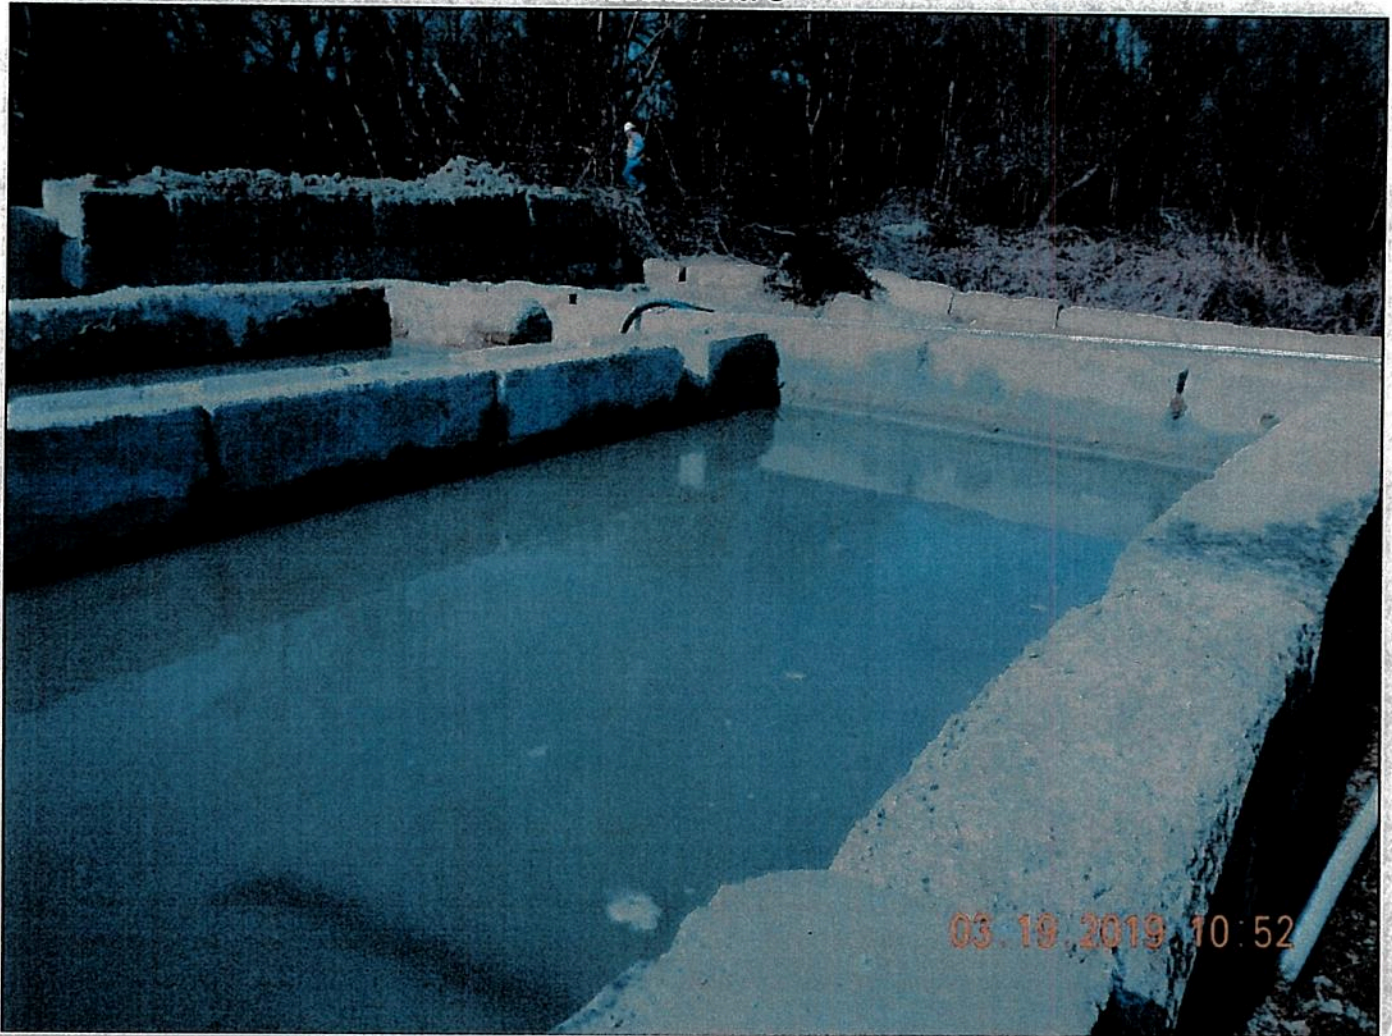
File Name	DSCN1849.JPG
Description	Photograph of the concrete washout basin.
Latitude	N 35° 27' 36.85"
Longitude	W 81° 15' 37.93"

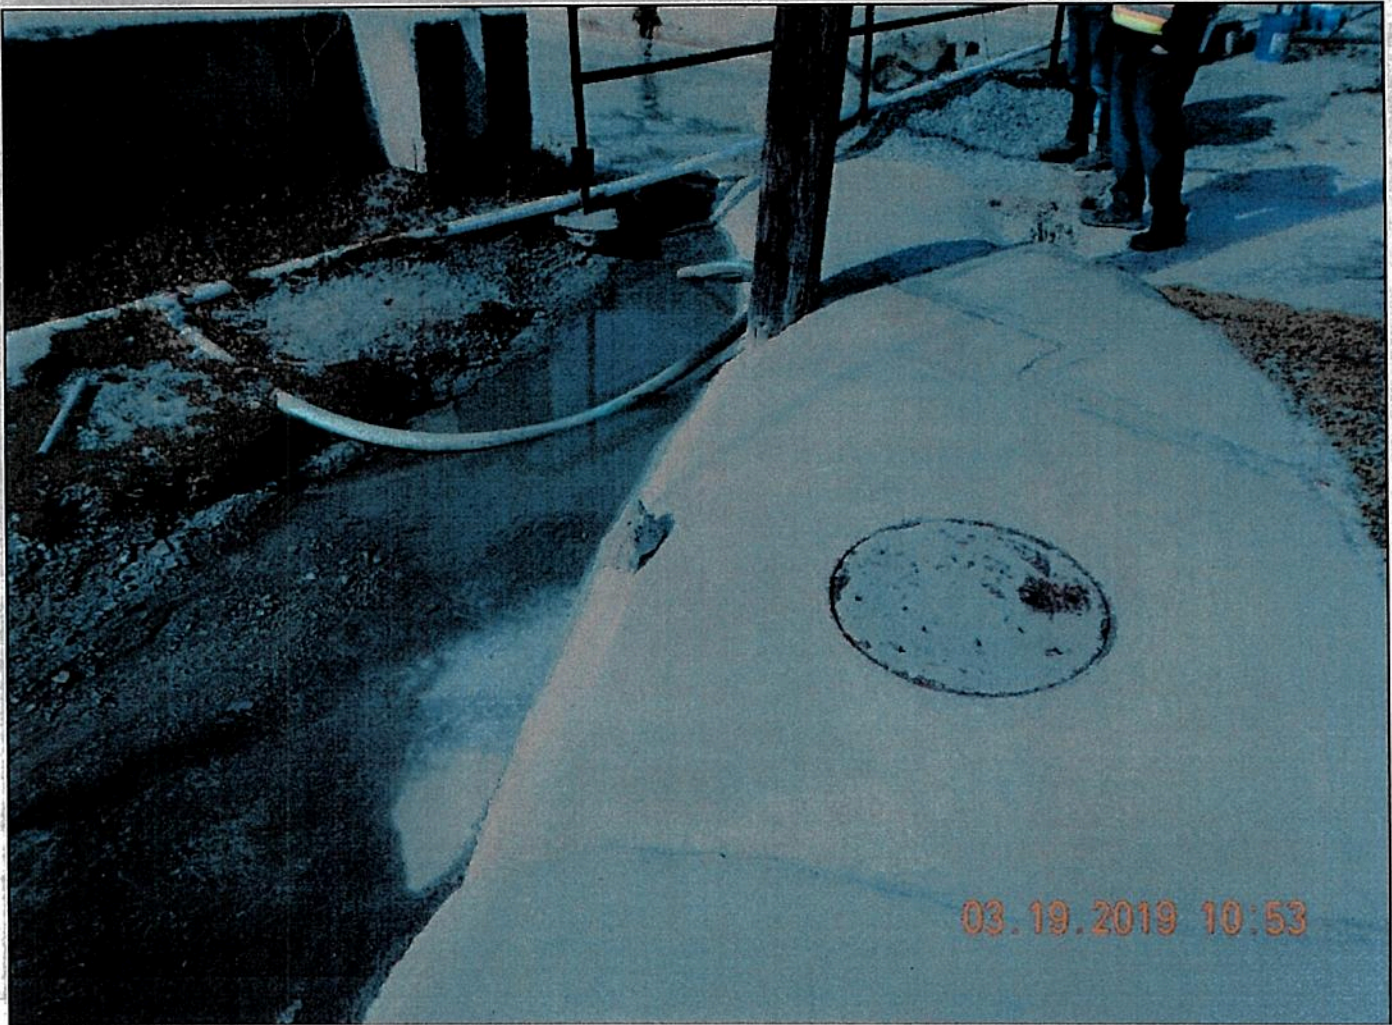
- A concrete sheen/accumulation was observed in the City of Lincolnton's sewer man hole likely from the discharging of concrete wash water to the sewer drain.

File Name	DSCN1850.JPG
Description	Photograph of the municipality's sanitary sewer manhole near the concrete washout station. According to facility personnel, it periodically pump concrete washout water via a portable pump into this sanitary sewer manhole.
Latitude	N 35° 27' 37.25"
Longitude	W 81° 15' 37.67"

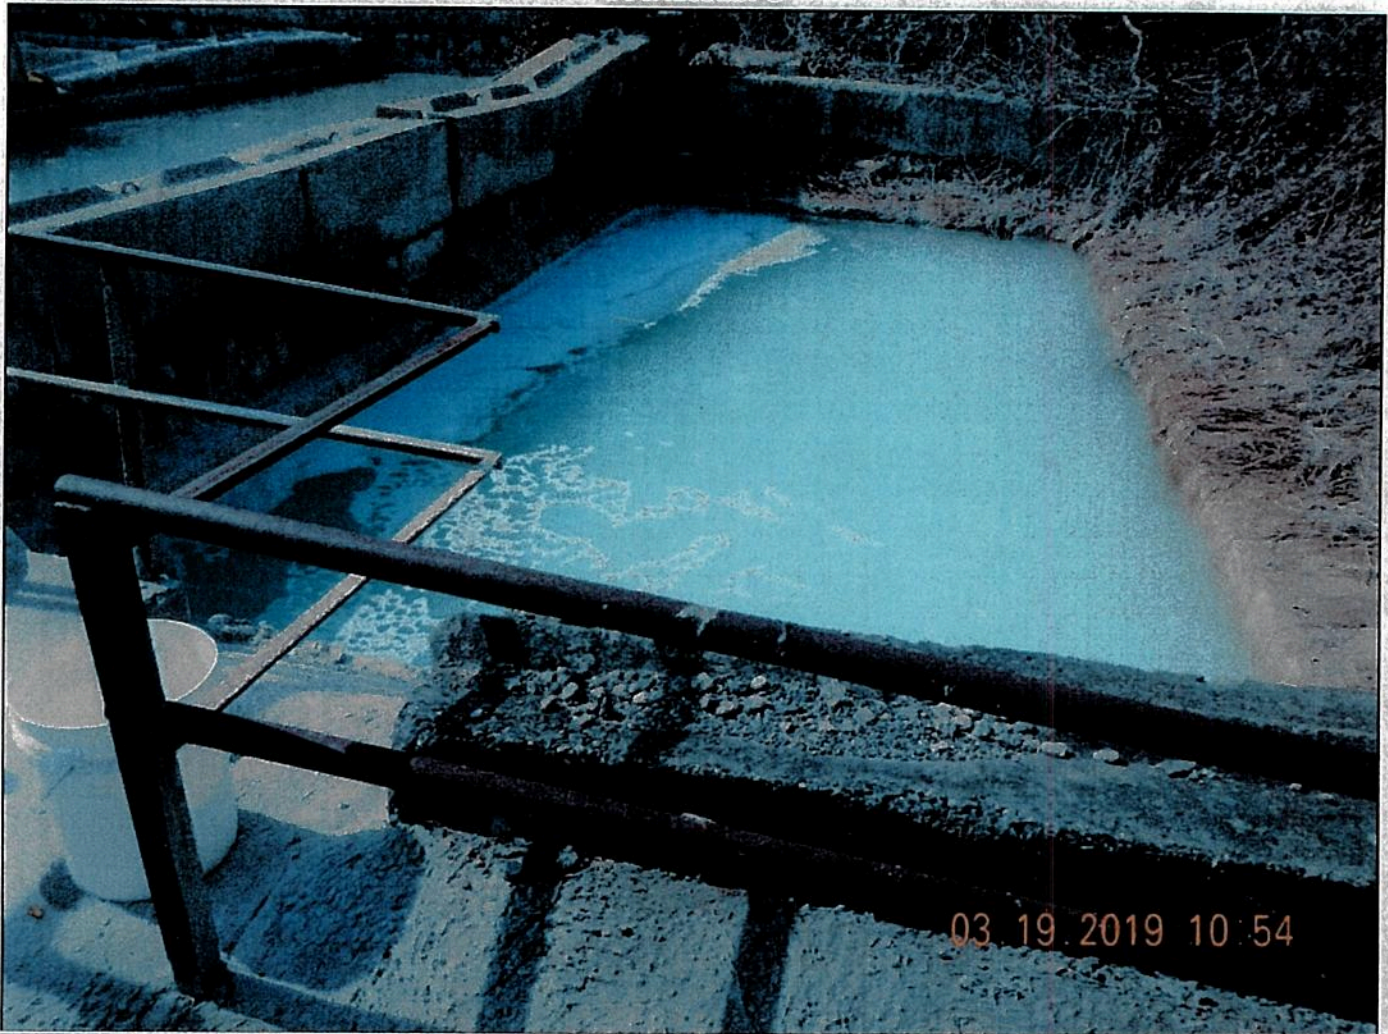
File Name	DSCN1851.JPG
Description	Photograph of the final treatment cell (Bright well) of the concrete washout. The water from this cell can be used in the process, dust suppression, or directed to the city sanitary sewer manhole.
Latitude	N 35° 27' 37.30"
Longitude	W 81° 15' 38.54"

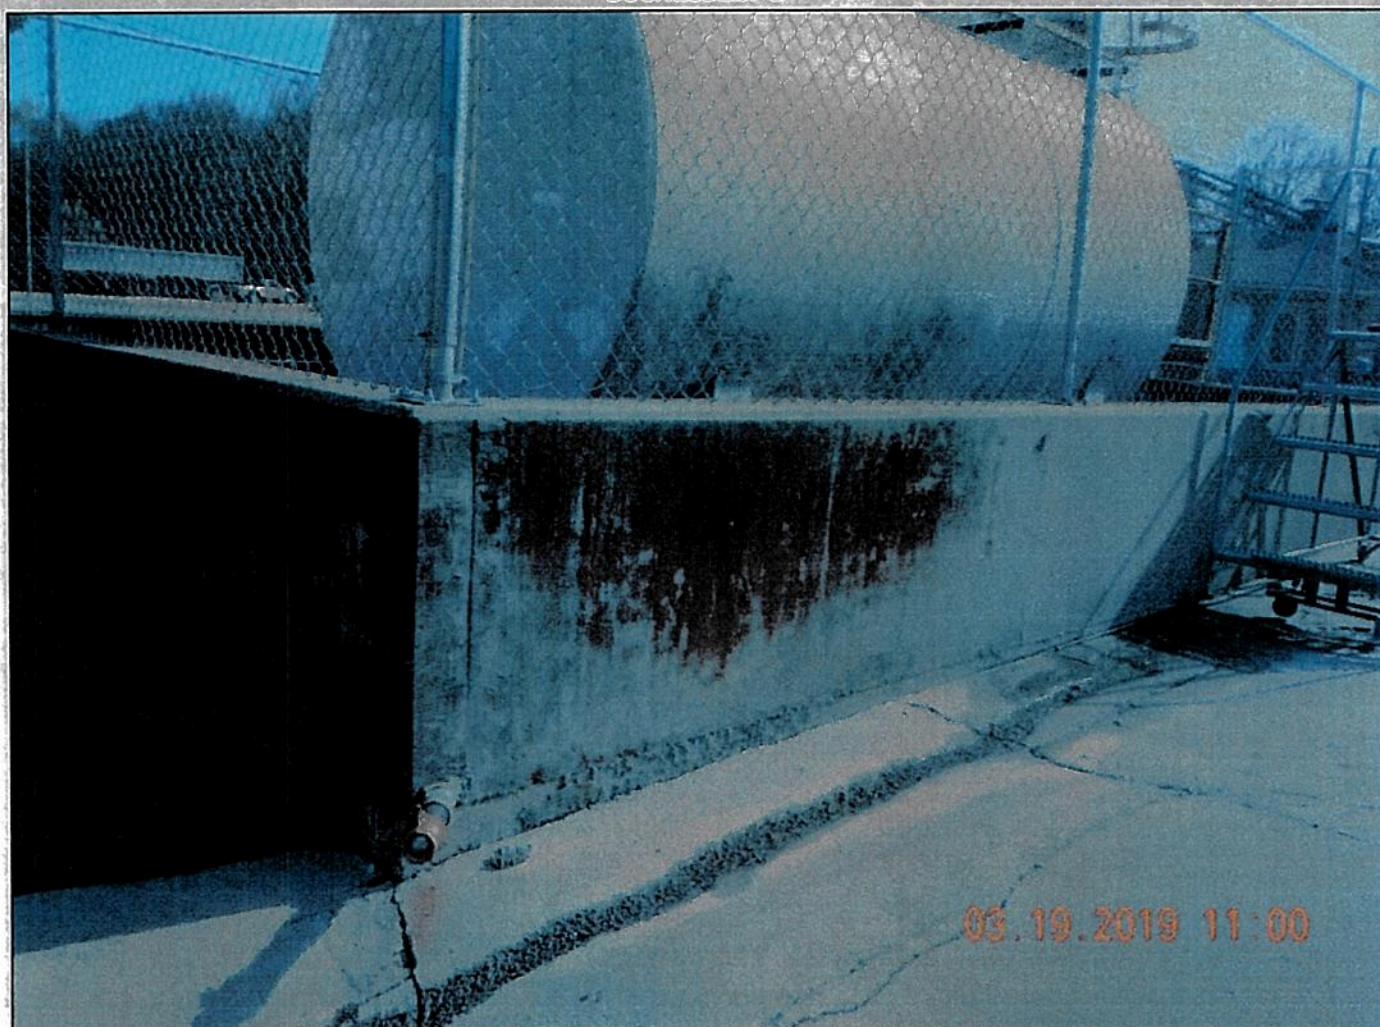
- The valves on the secondary containment structures did not have a locking mechanism
  - The outfall near the southeast corner of the facility, which the facility claims to have closed out, was not water tight or properly bermed to assure there was no potential to discharge

File Name	DSCN1852.JPG
Description	Photograph of the diesel fuel tank and its secondary containment structure. A drainage valve was observed in the secondary containment structure. The valve was closed at the time of the inspection. Although a lock was not in place on the valve, the valve arm had been removed.
Latitude	N 35° 27' 37.16"
Longitude	W 81° 15' 37.49"
